WIND AND HAIL DAMAGE TO ASPHALT SHINGLES IN IOWA

Major Subject: Agricultural Engineering
(Farm Structures)

Iowa State College
1948

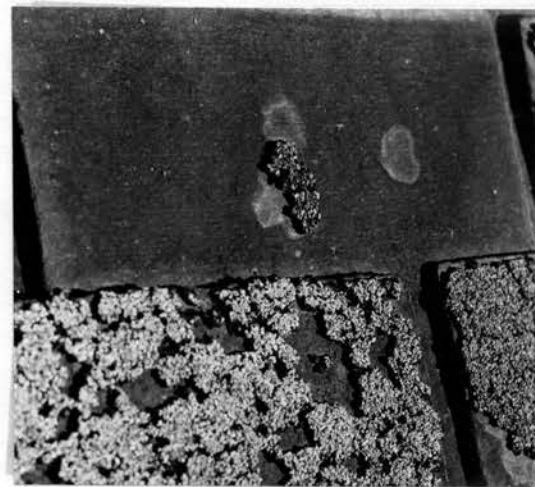
Fig. 24. Irregular Weather-
ing

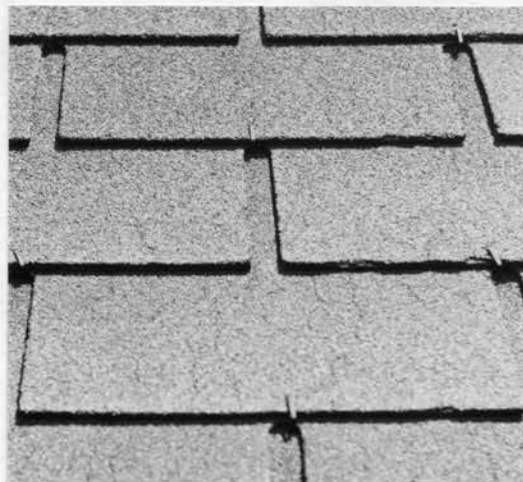
Fig. 29. Ten-Year Old
Chipped Shingle

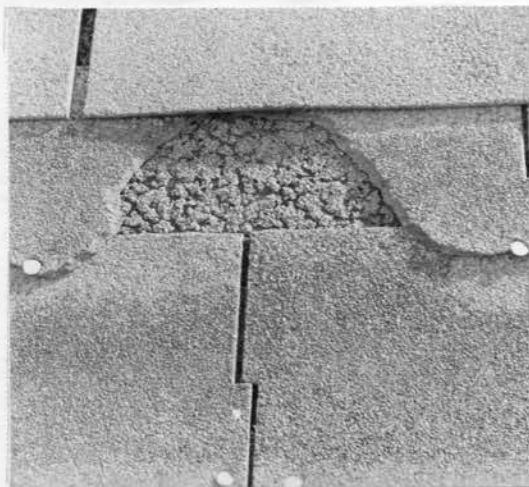
Fig. 30. Nailed at an
Improper Angle

Nails that are not driven in straight cause the head to cut the shingle as is shown in Figure 30 and offers less resistance to holding the shingle on the roof. To determine if this was realized by lumber dealers, the

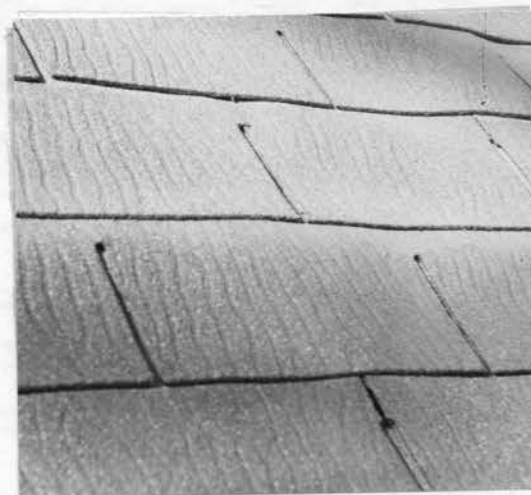
Fig. 31. Too Much Exposure

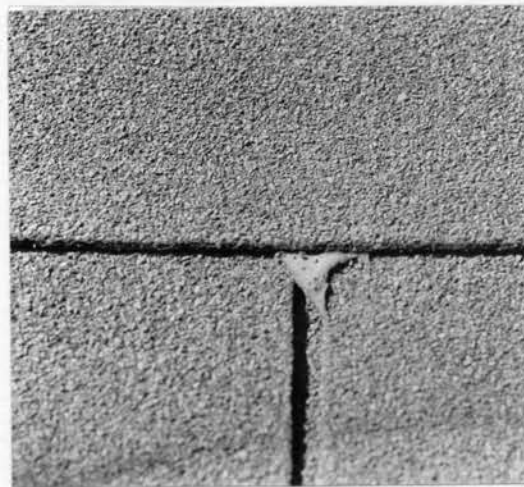
Fig. 59. Careless Cementing of Tabs

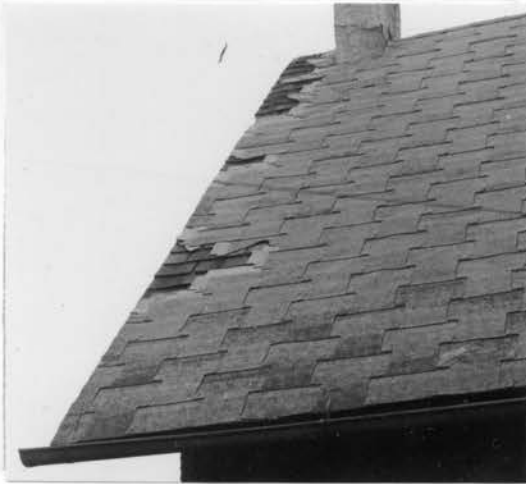
Fig. 63. A Tite-on
Shingle Failure

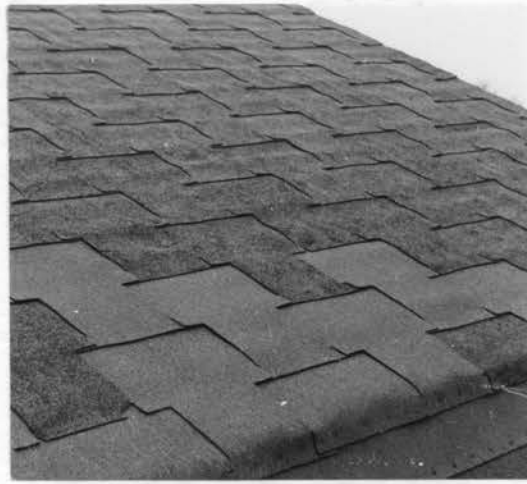
Fig. 64. A Tite-on Shingle
Failure and Repair

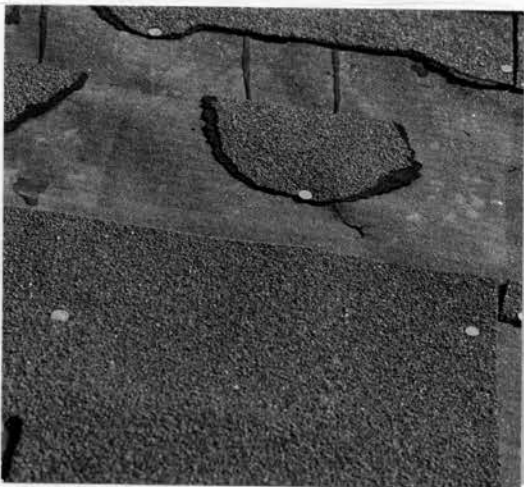
Fig. 65. Too High Nailing

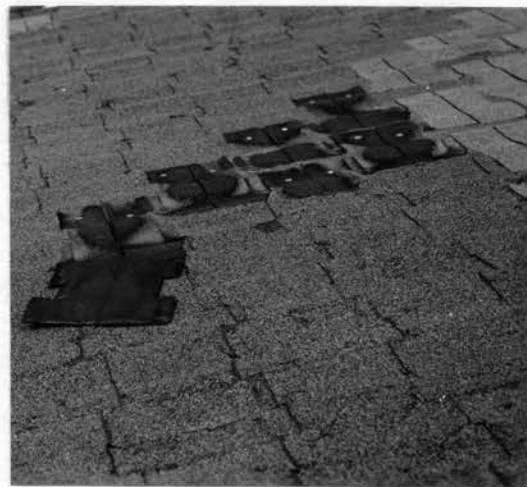
Fig. 66. A Tee-Lock
Shingle Failure

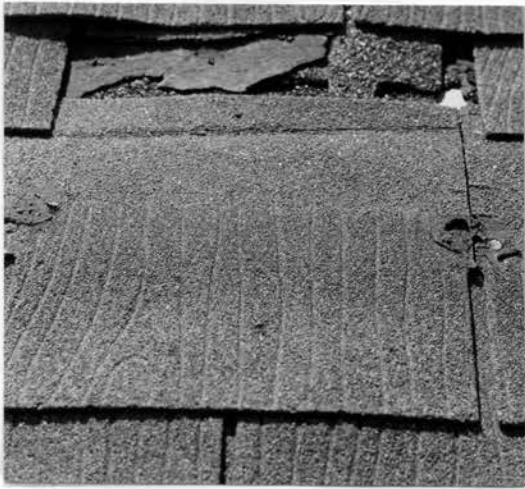
The one shingle that failed that was cemented as well as fastened with a nail is shown in Figure 67. Cementing is not a cure-all if care is not taken in application. In this instance the tab did not come into contact with the shingle below before the cement dried. Cement is applied in most instances after the roof has been applied and if the day is not rather warm, the tabs do not settle down and seal but remain curved and the cement is allowed to dry. Cement should be applied on a clear day with an air temperature of around 75° F. If the day is cloudy the roof temperature will approach air temperature and will not be hot enough to cause good sealing of the two tabs. It is also preferable that the cement be applied as the roof is applied. The cement should be applied to the shingle that is already nailed, just above or on the nail heads for either square butt or

Fig. 67. Careless
Cementing

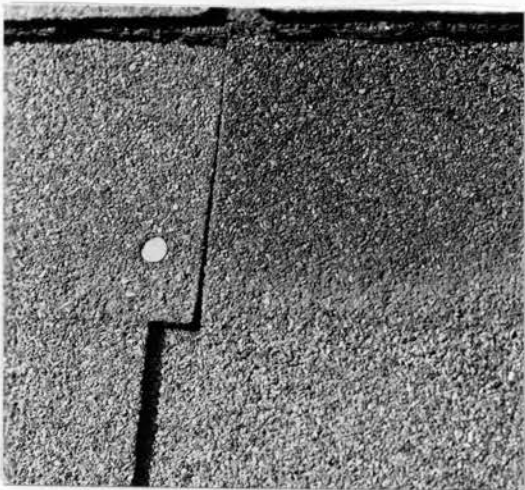
Fig. 69. An Inadequate
Number of Nails

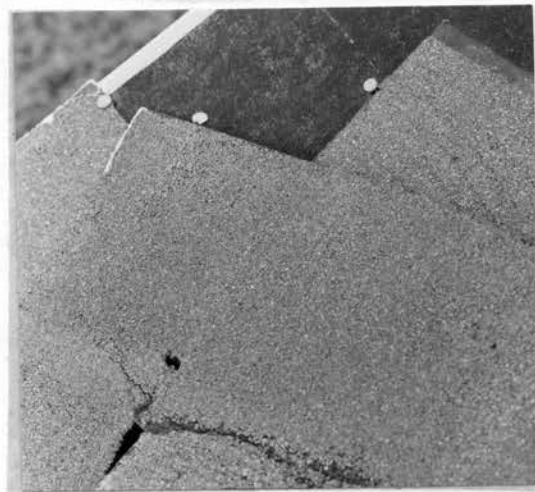
Fig. 70. Use of a Too Small
Nail Head

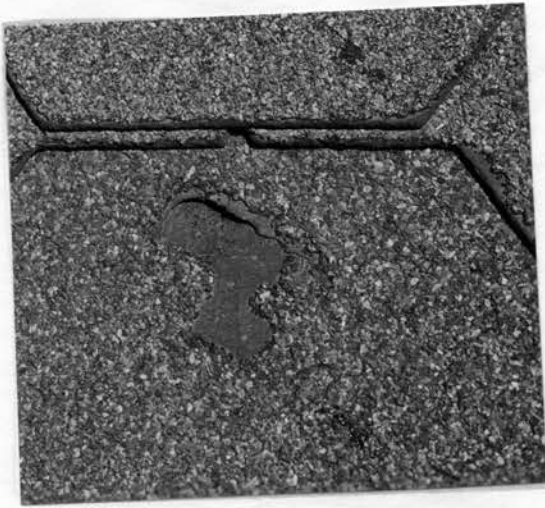
Fig. 71. Hail Damage Over
Wood Shingles

There were twelve different asphalt shingle roofs inspected for hail loss. Figures 71 and 79 show typical cases of hail damage. Figure 79 is an example of an asphalt shingle hit 13 years ago and Figure 71 is an example of an asphalt shingle hit two weeks prior to the time the picture was taken. The cause for failure, any deck that is not perfectly smooth, has been discussed. It is definitely believed that hail will do no material damage to an asphalt shingle except for knocking a few granules loose. This will not hurt the water turning ability of the shingle at all, as is shown in the upper left part of the picture in Figure 79, which was damaged by hail 13 years ago. However, it does spoil the original appearance of the roof and for only the damage to the appearance and the cost of a dressing should the insurance companies pay. A dressing that helps seal the bitumen in should be used. Various other kinds

It is recommended that a closely matched deck be constructed of tongue and groove lumber under any asphalt shingle. This is done so that hail damage cannot occur and so that nails have a secure member to be fastened to in order that they will not pull out when wind pressure is exerted on an asphalt shingle tab. In repair work old wood shingles should be removed and the deck replaced as shown in Figure 73. Any old asphalt shingles or roll roofing should also be removed. It has been recommended by many people that this old material offers insulation and a protection for the new roof, but the disadvantages offset the advantages of removing the old material. It will be necessary to use a tarpaulin on a house to protect the contents against damage with this type of replacement with asphalt shingles. To eliminate this cost of removal of the old roof, a material is needed that could be spread over the old shingles whether wood or asphalt to give a smooth flat surface. This material must not be too hard or too soft, and must be economical and easy to apply.

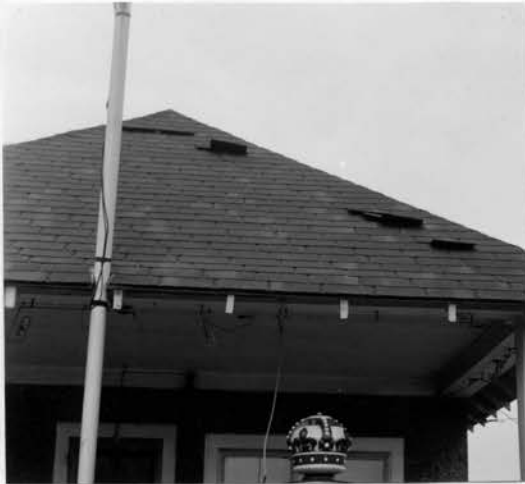
Fig. 75. Shingle Blowing Up
on a Windy Day

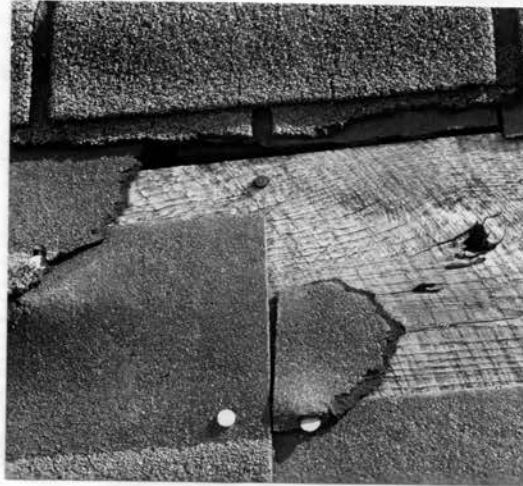
Fig. 76. Green Sheathing

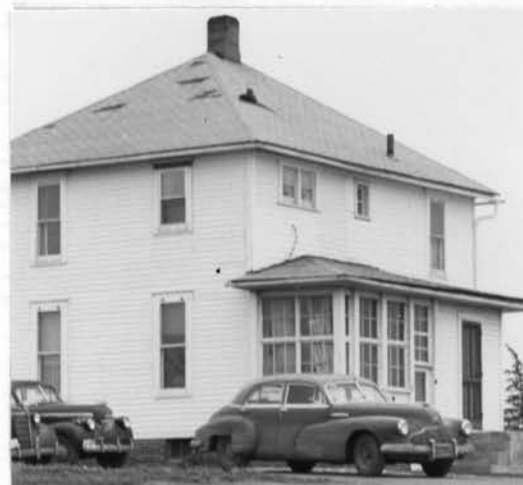
Fig. 78. Shingles Blowing
and Later Found Damaged

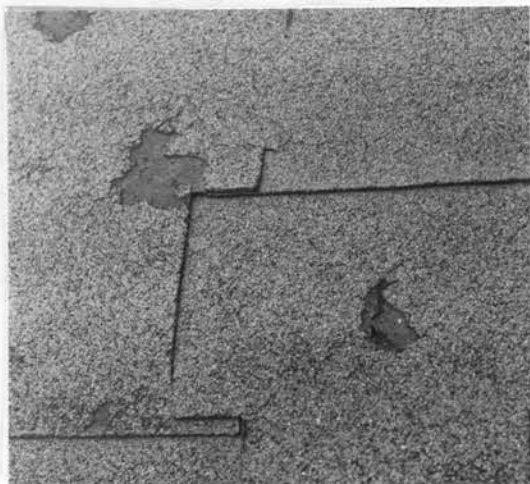
Fig. 79. Hail Damage of
13 Years

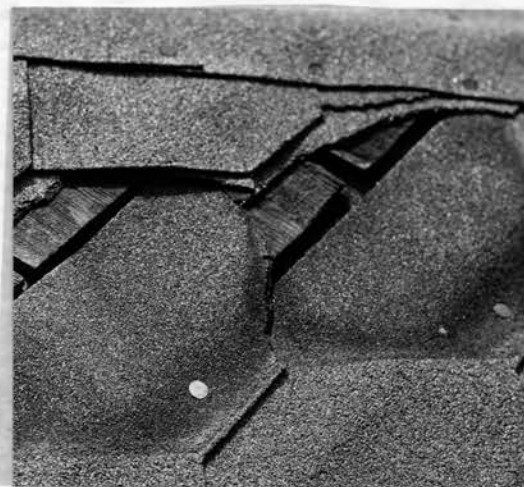
Fig. 80. A Typical Failure
by Breaking
